Sacramento Regional County Sanitation District

CATHODIC PROTECTION ANALYSIS REPORT – YEAR 3

December 17, 2021

V&A Project No. 16-0276

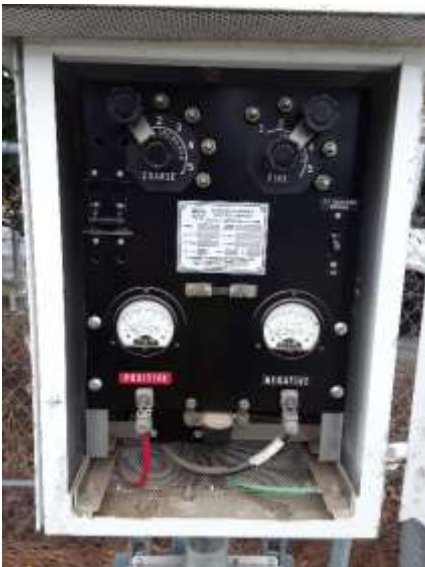
Photo 5-1. N24-CPNL0033A Rectifier Panel

Based on the rectifier output measurements, the rectifier and deep anode well were operating as intended and did not require replacement at that time. Based on the results of the pipe-to-soil potential survey, the pipeline was achieving the NACE SP0169 –850 mV polarized potential criterion for adequate corrosion control and the rectifier outputs did not require adjustment. Even though corrosion of the pipeline was mitigated, the rectifier was found to be discharging approximately 1 amp, which is well below its rated capacity of 24 amps. Due to the pipeline achieving NACE criteria at a low current output, the expected remaining useful life of the rectifier and deep anode well is greater than 20 years.

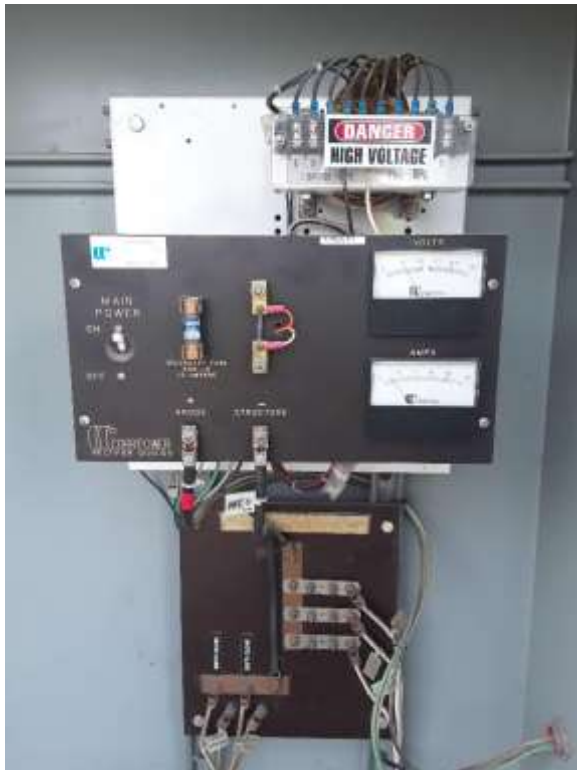
Photo 5-3. N52-CPNL0001A Rectifier Panel

Based on the rectifier output measurements, the rectifier and anode wells are operating as intended and do not require replacement at this time. Based on the results of the casing-to-soil potential survey, the casings are achieving the NACE SP0169 –850 mV polarized potential criterion for adequate corrosion control and the rectifier outputs did not require adjustment. Even though corrosion of the pipeline was mitigated, the rectifier was found to be discharging approximately 1 amp, which is well below its rated capacity of eight amps. The current outputs of the anodes should continue to be monitored as the rectifier does not appear to be a modern type of rectifier.
